Republika ng Pilipinas  
PAMBANSANG PANGASIWAAN NG PATUBIG  
(National Irrigation Administration)  
Gusaling APC, Quezon Memorial Circle  
Diliman, Lungsod ng Quezon

MC # 41 s. 1970

MEMORANDUM CIRCULAR

SUBJECT : Prevention of Failure on Ford Truck Engines Model 1140.

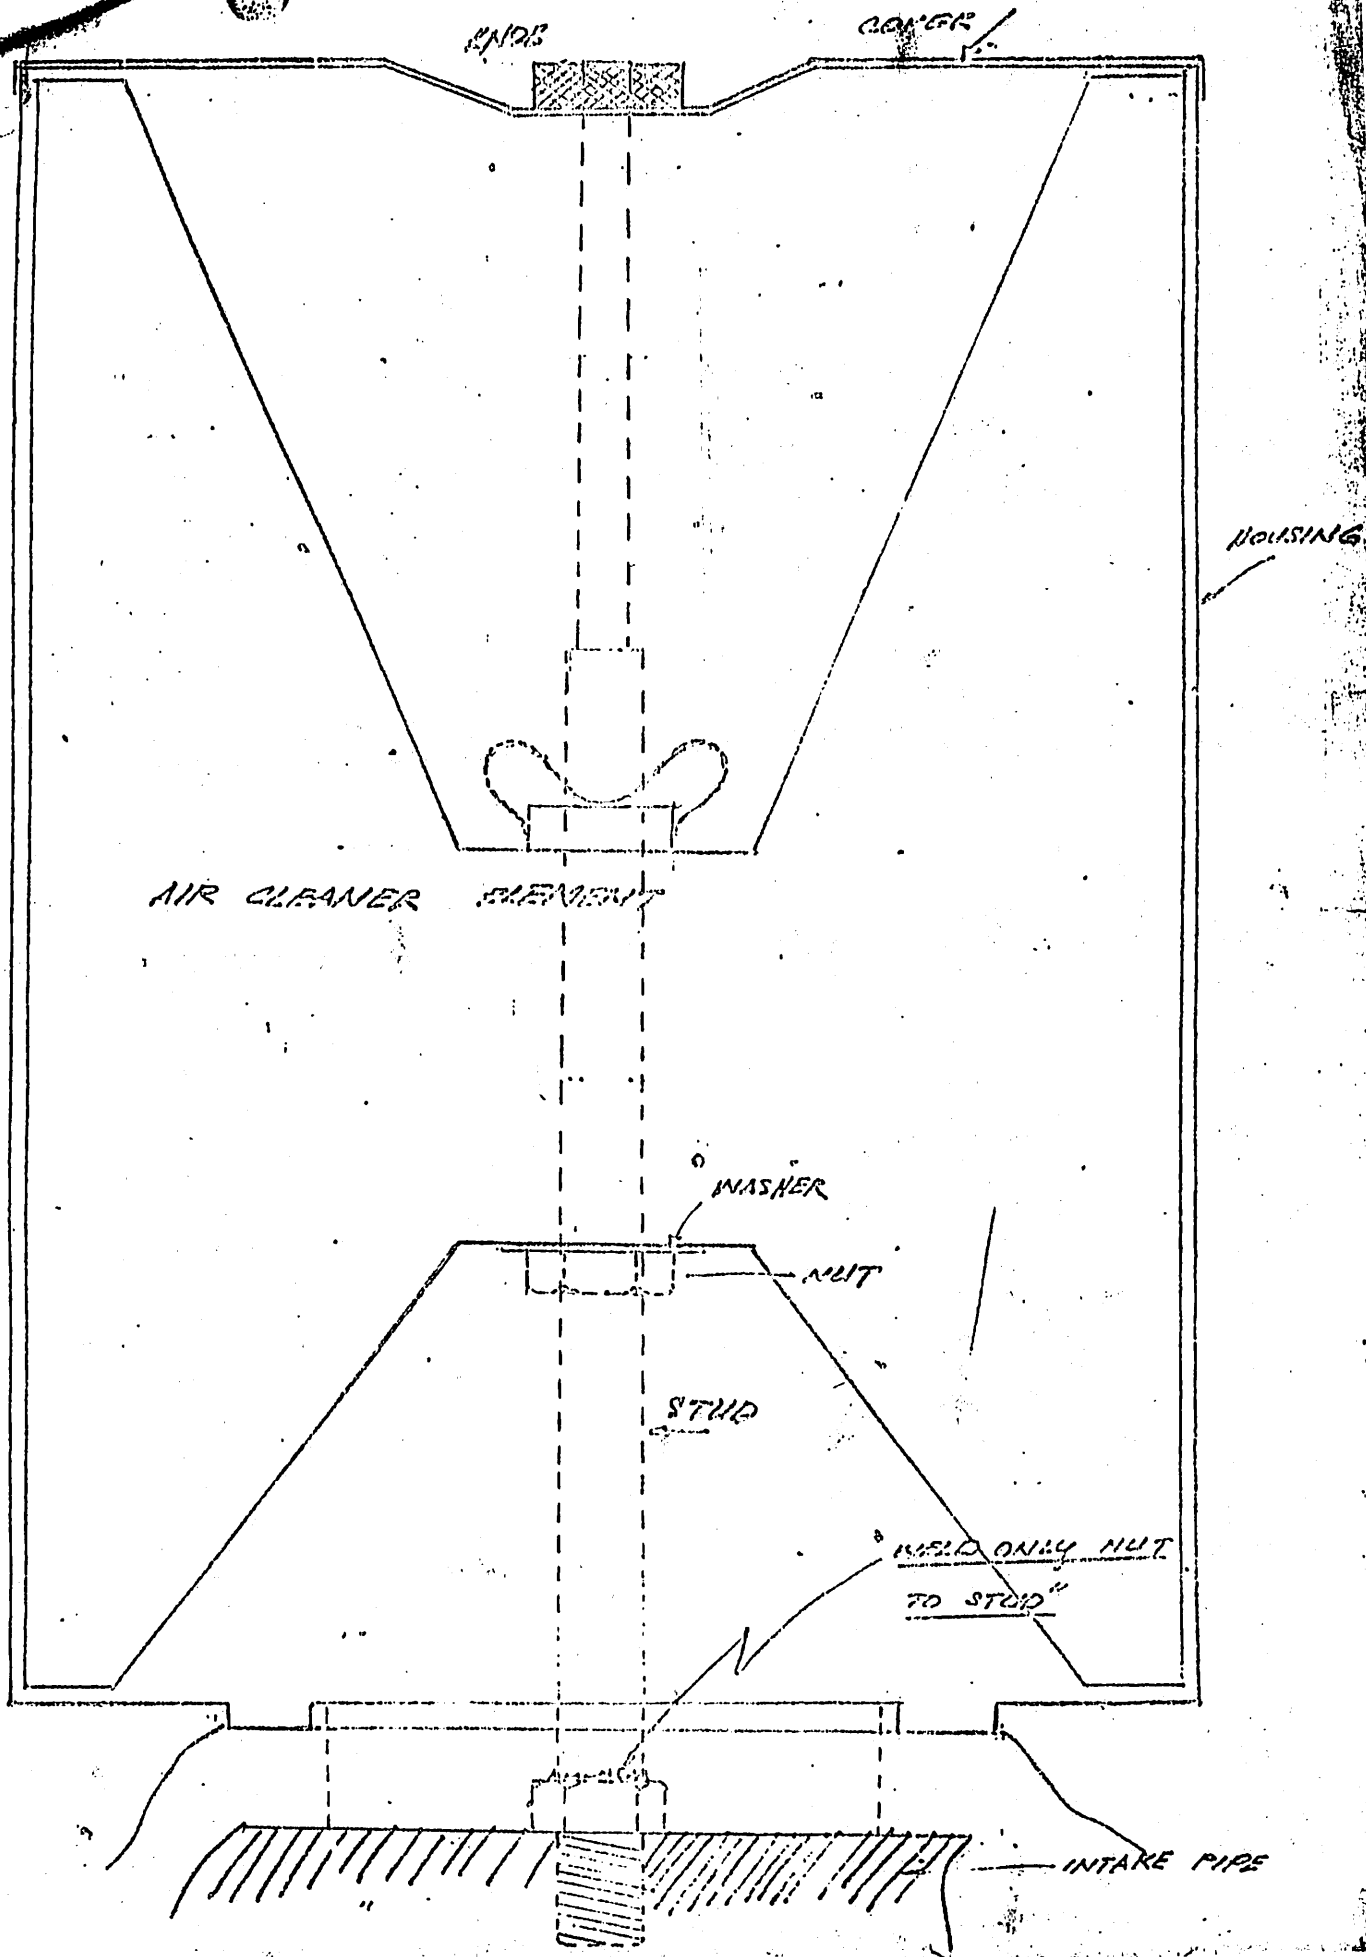
Todate NIA has experienced three engine failures on our Ford Trucks procured from the \$4.7 M loan. These failures which are of a serious nature result in the cracking of cylinder walls and scuffing of piston tops. The suspected cause of this mechanical trouble is the dropping of a nut inside the cylinder whenever the air cleaner is serviced. This nut holds the stud in place, while the stud secures the air cleaner to the air inlet pipe.

As a precaution against the possible occurrence of a mechanical failure of this nature, care should be exercised in removing the stud to avoid the falling of the nut. Spot weld the nut to the stud to make it a permanent repair. Details of repair is enclosed.
